Doubletree Hotel Fire New Orleans, Louisiana

Doubletree Hotel Fire New Orleans, Louisiana (July 19, 1987)

Investigated by: Jeffrey M. Shapiro, P.E.

**This is Report 008 of the Major Fires Investigation Project conducted
by TriData Corporation under contract EMW-86-C-2277 to the United
States Fire Administration, Federal Emergency Management Agency.**

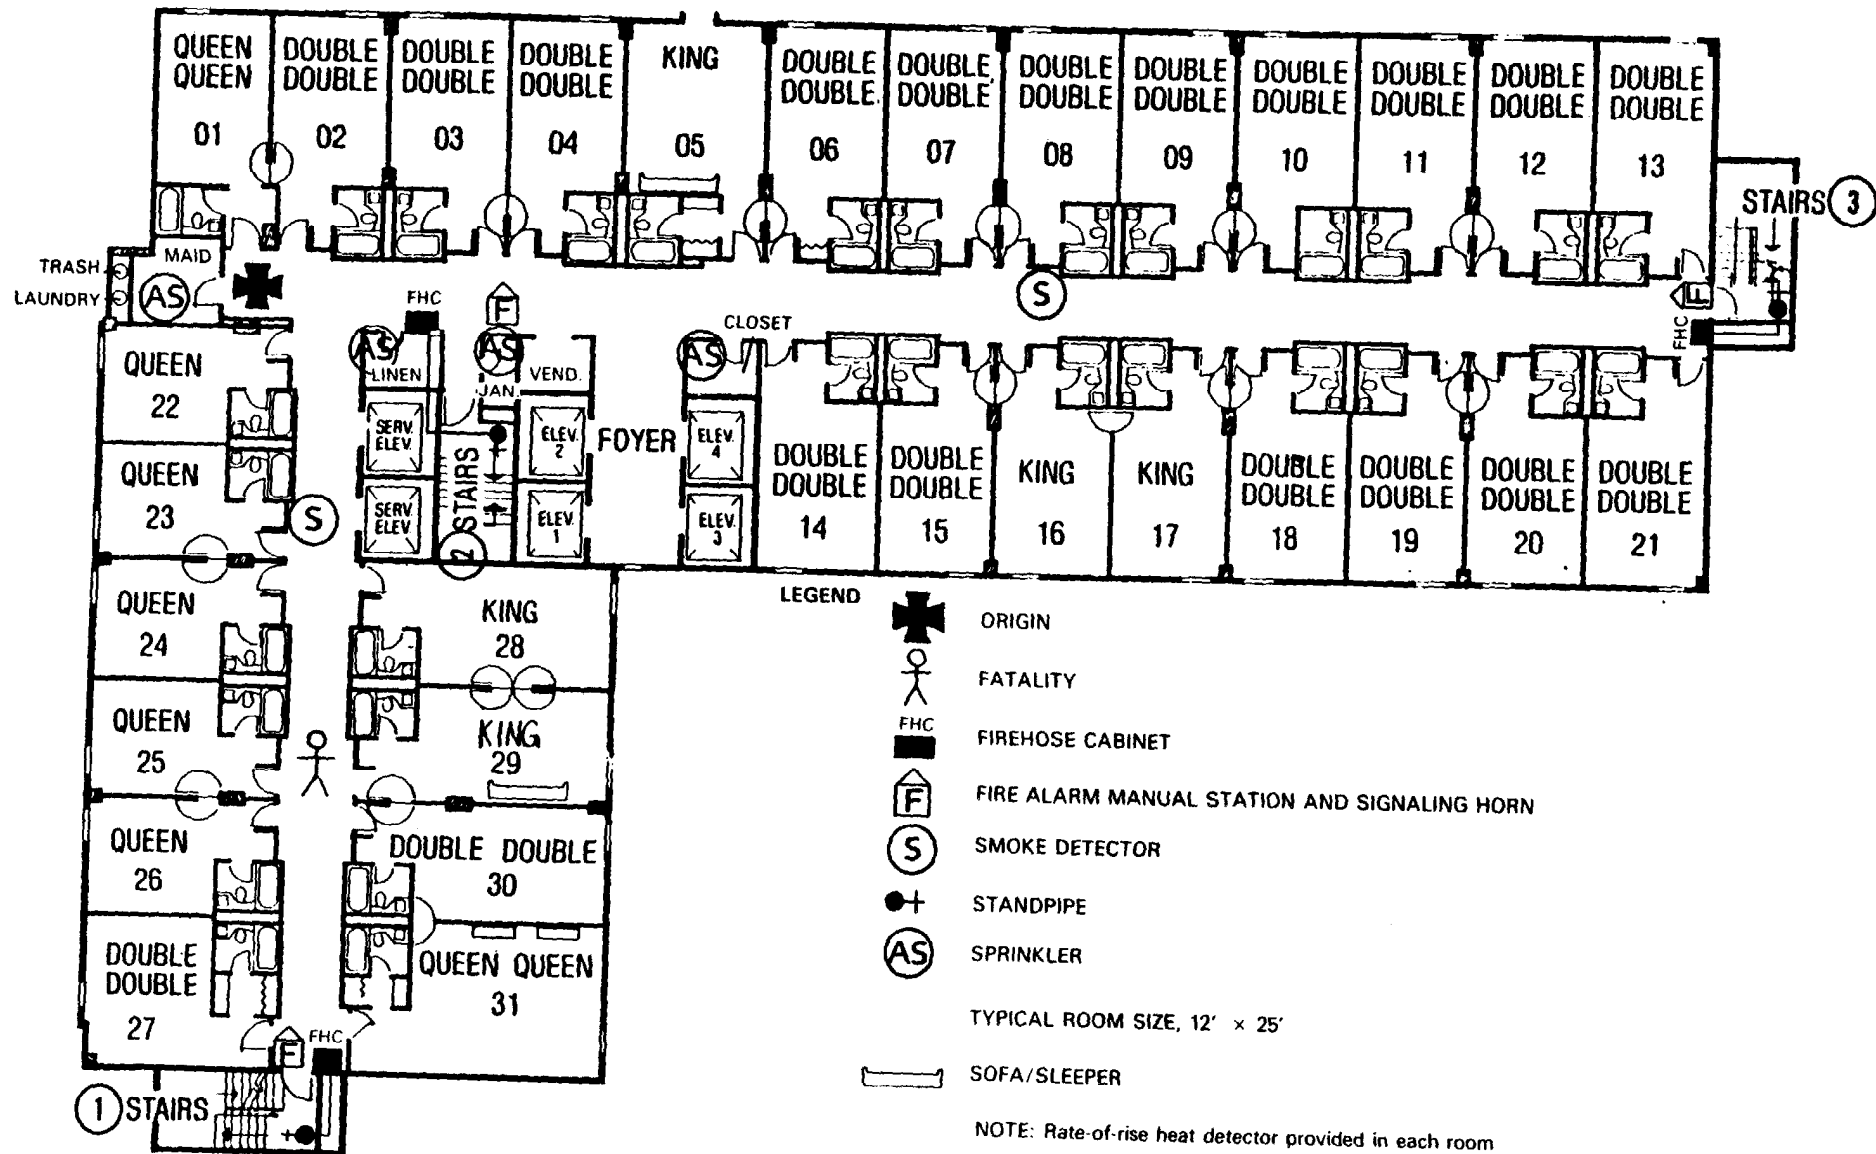
FIGURE 3
FLOOR PLAN
10th FLOOR

At the time of the fire, the hotel was equipped with a substantial complement of fire protection systems, considering its age. In addition to a partial automatic sprinkler system, the hotel was provided with a combination standpipe for both occupant and Fire Department use, automatic and manual fire alarm systems, and portable fire extinguishers. Figure 3 shows the location of these systems on a typical floor.
